Subject: Pre-CERCLA Screening Report
2400 Central Avenue Former Dry Cleaner, Kearney, Nebraska
U.S. EPA Region 7 START 5, Contract No. 68HE0719D0001
Task Order No. 19F0076.006
Task Monitor: Kumud Pyakuryal, EPA Nebraska Site Assessment Manager

PRE-CERCLA SCREENING REPORT
2400 CENTRAL AVENUE FORMER DRY CLEANER
KEARNEY, NEBRASKA

Superfund Technical Assessment and Response Team (START) 5 Contract
Contract No. 68HE0719D0001, Task Order 19F0076.006

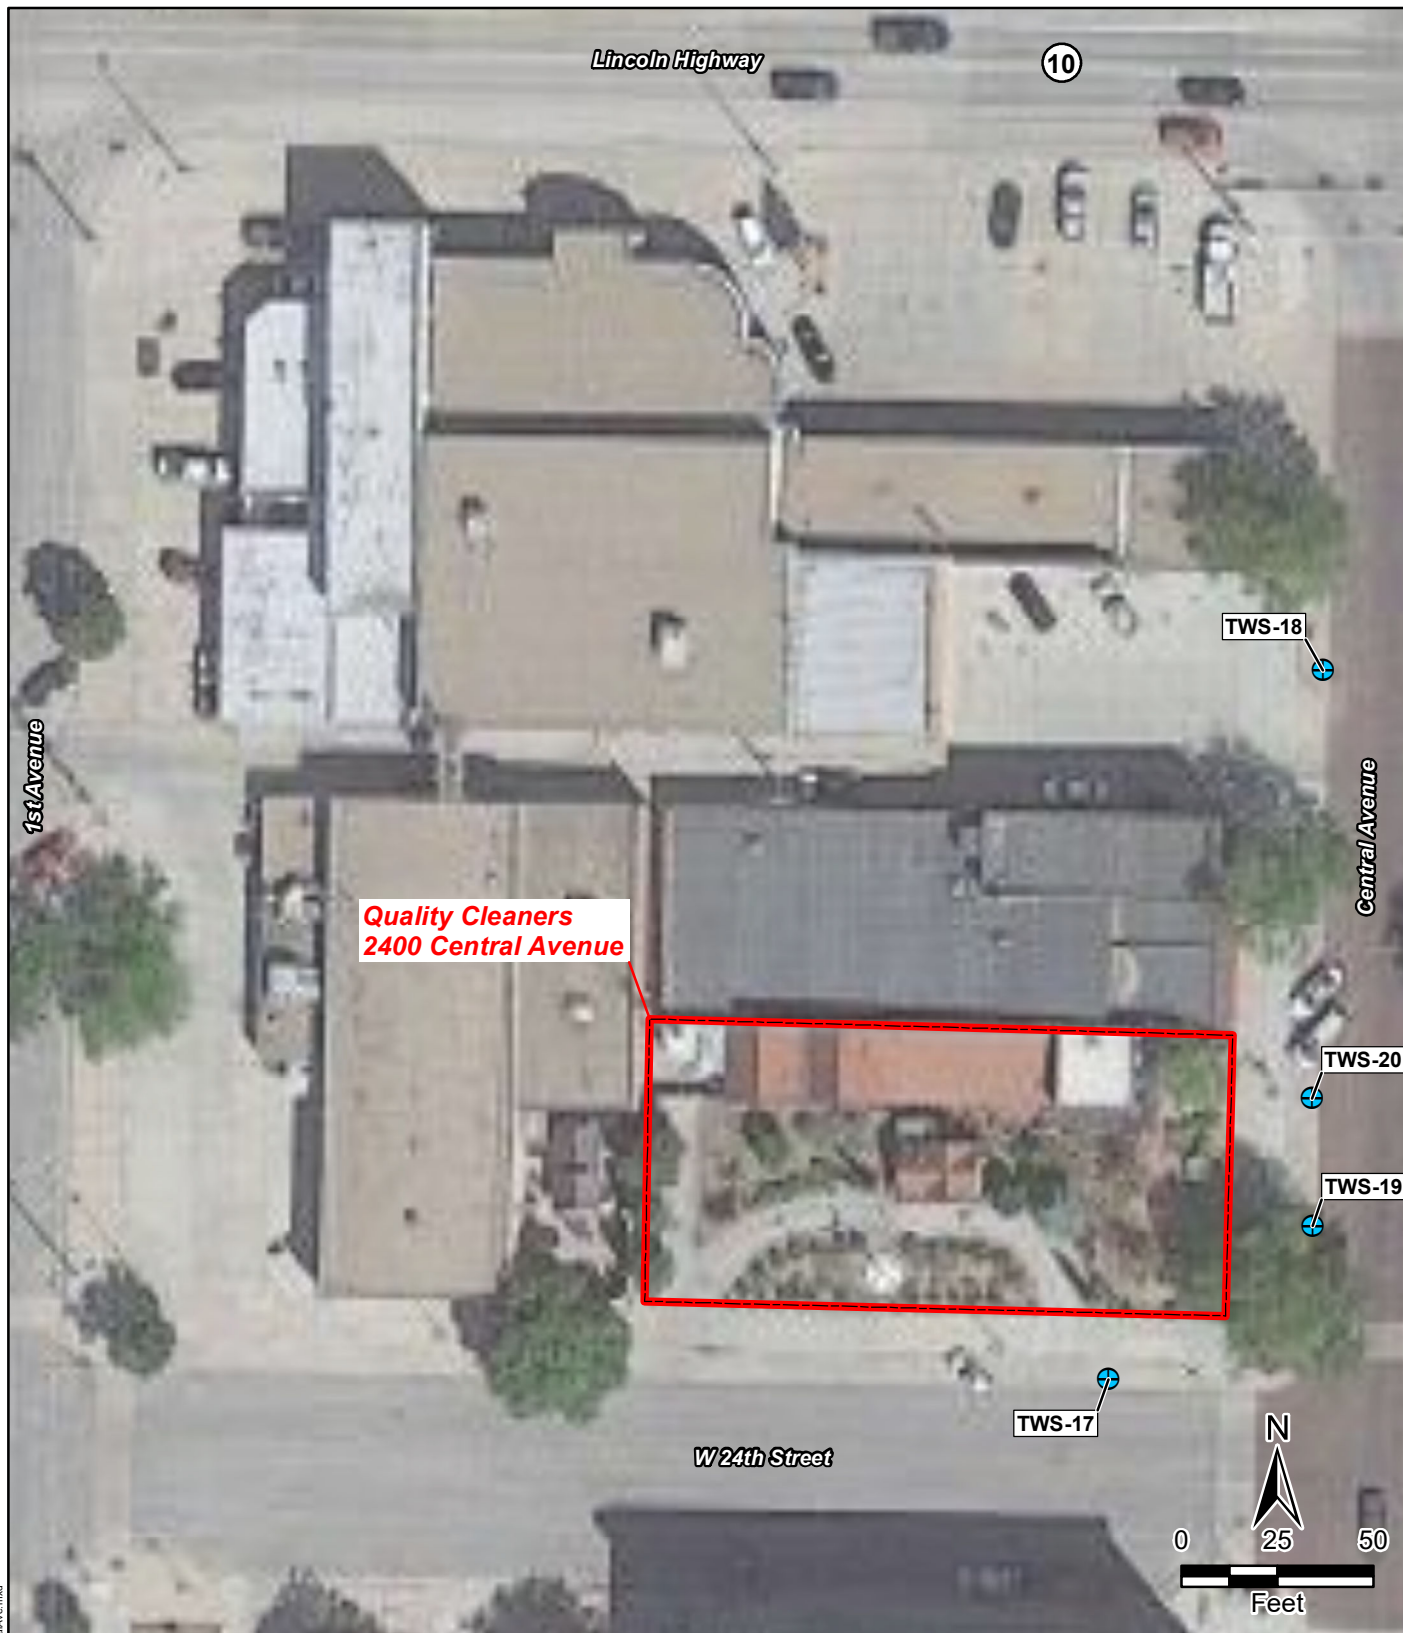
- ⊕ DPT groundwater sample location
- Approximate site boundary

Groundwater samples were collected from temporary wells (TW) at four locations around the site—one south, two east, and one north (background sample). From north to south, temporary well identifications are TWS-18, TWS-20, TWS-19, and TWS-17.

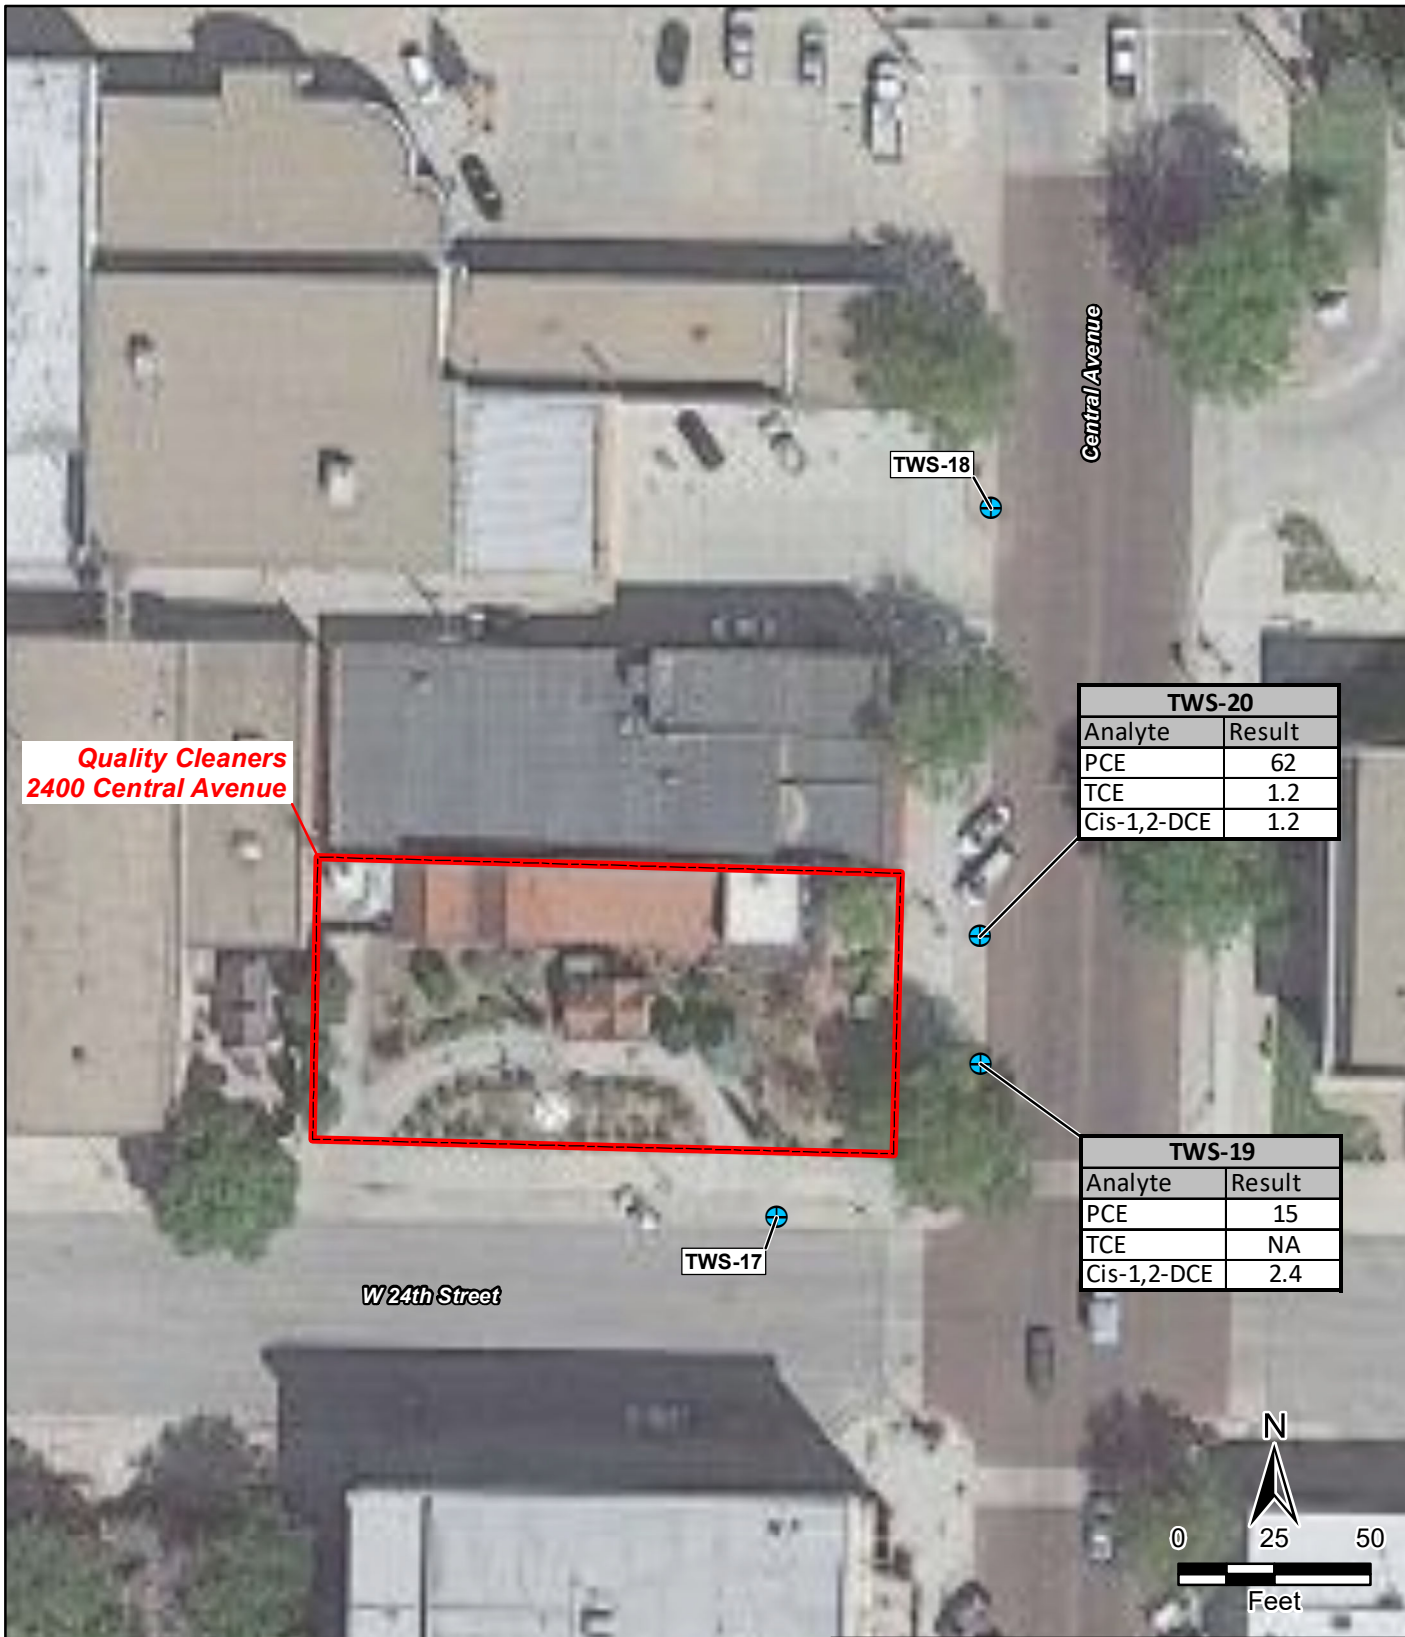
⊕ DPT groundwater sample location

PCE, commonly associated with dry cleaners, was detected in groundwater samples from wells TWS-19 and TWS-20. PCE was detected at 15 and 62 micrograms per liter (µg/L), respectively, in samples collected from TWS-19 and TWS-20—exceeding its federal maximum contaminant level (MCL). *Cis*-1,2-DCE was detected in wells TWS-19 and TWS-20 at 2.4 and 1.2 µg/L, respectively. TCE was also detected in TWS-20 at 1.2 µg/L. TWS-19 and TWS-20 were approximately 20 feet from the northeast and southeast corners of the site, respectively.

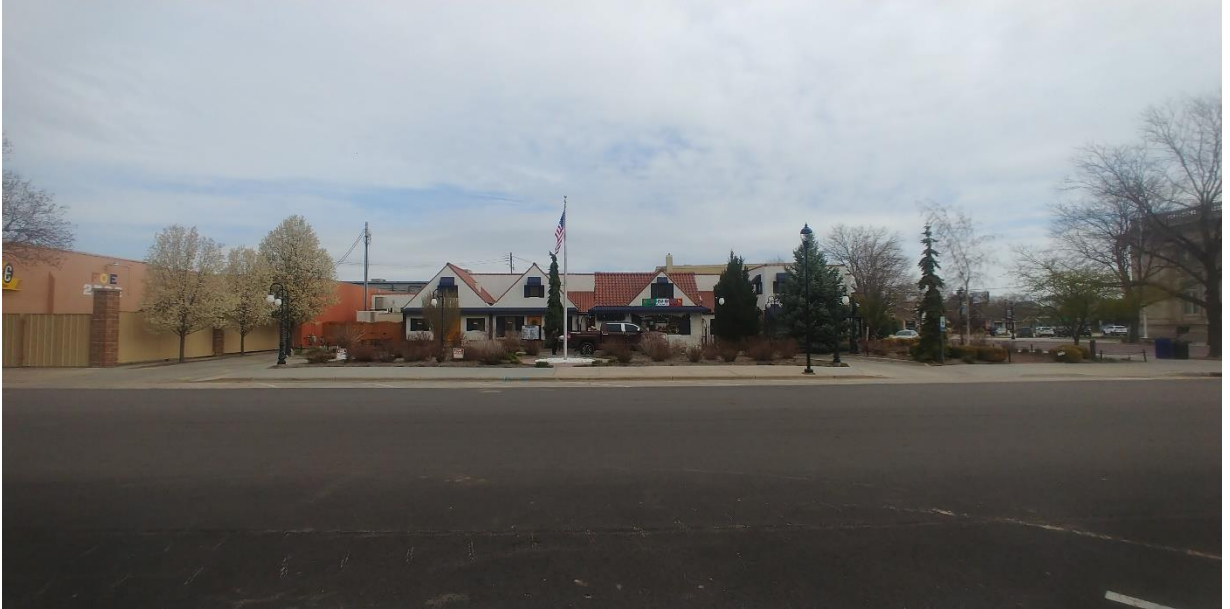
TETRA TECH PROJECT NO. 103X903019F0076 Direction: North	DESCRIPTION	This photo shows the site.	1
	CLIENT	U.S. Environmental Protection Agency Region 7	Date
	PHOTOGRAPHER	Thomas Kaley	4/22/2021

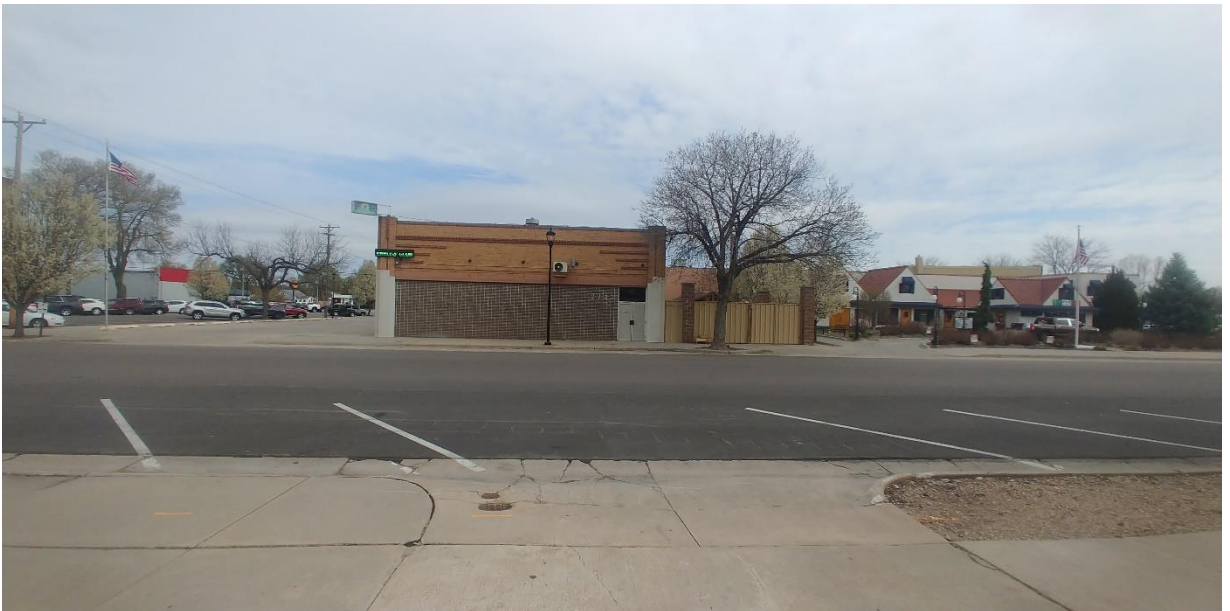
TETRA TECH PROJECT NO. 103X903019F0076 Direction: North	DESCRIPTION	This photo shows the property adjacent to and west of the site.	2
	CLIENT	U.S. Environmental Protection Agency Region 7	Date
	PHOTOGRAPHER	Thomas Kaley	4/22/2021

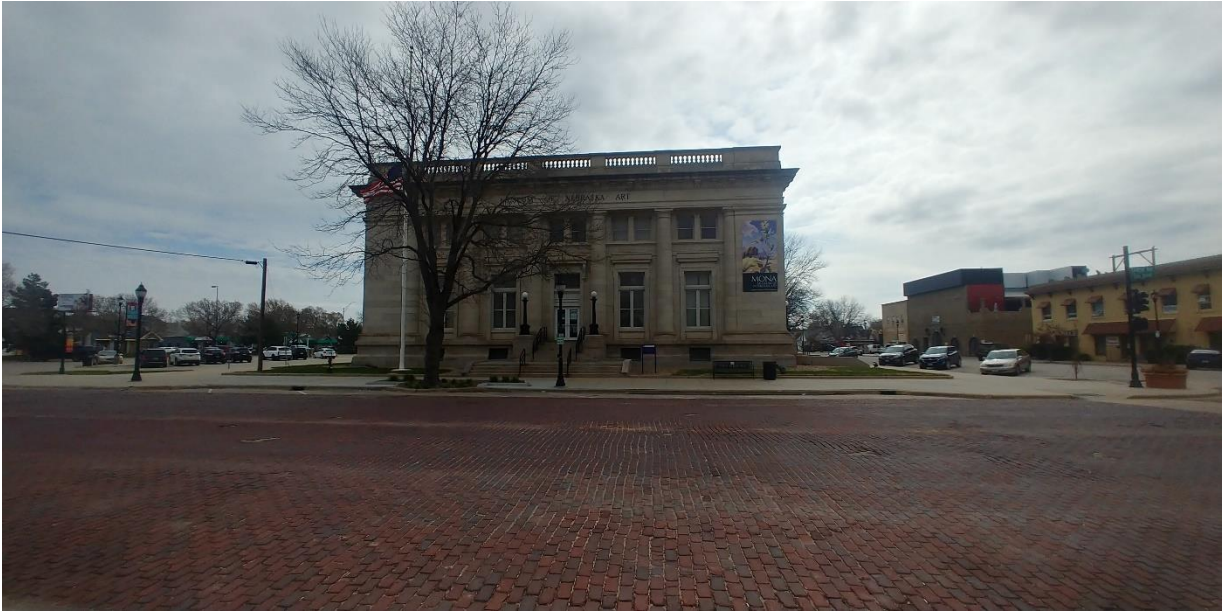
TETRA TECH PROJECT NO. 103X903019F0076 Direction: East	DESCRIPTION	This photo shows the property adjacent to and east of the site.	3
	CLIENT	U.S. Environmental Protection Agency Region 7	Date
	PHOTOGRAPHER	Thomas Kaley	4/22/2021

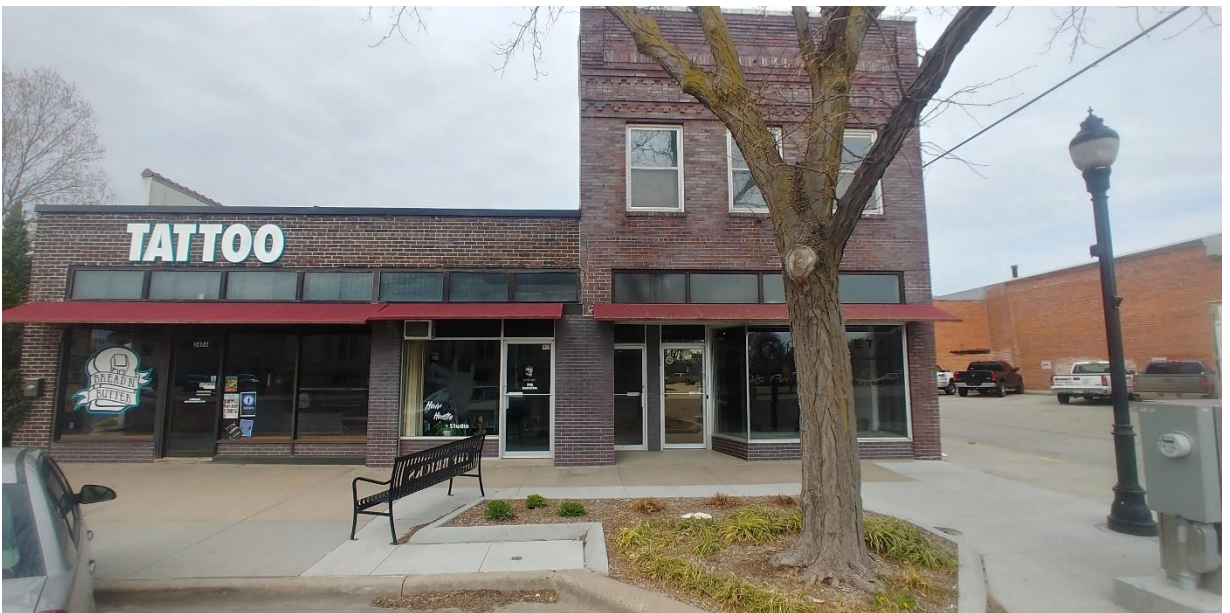
TETRA TECH PROJECT NO. 103X903019F0076 Direction: West	DESCRIPTION	This photo shows the property adjacent to and north of the site.	4
	CLIENT	U.S. Environmental Protection Agency Region 7	Date
	PHOTOGRAPHER	Thomas Kaley	4/22/2021

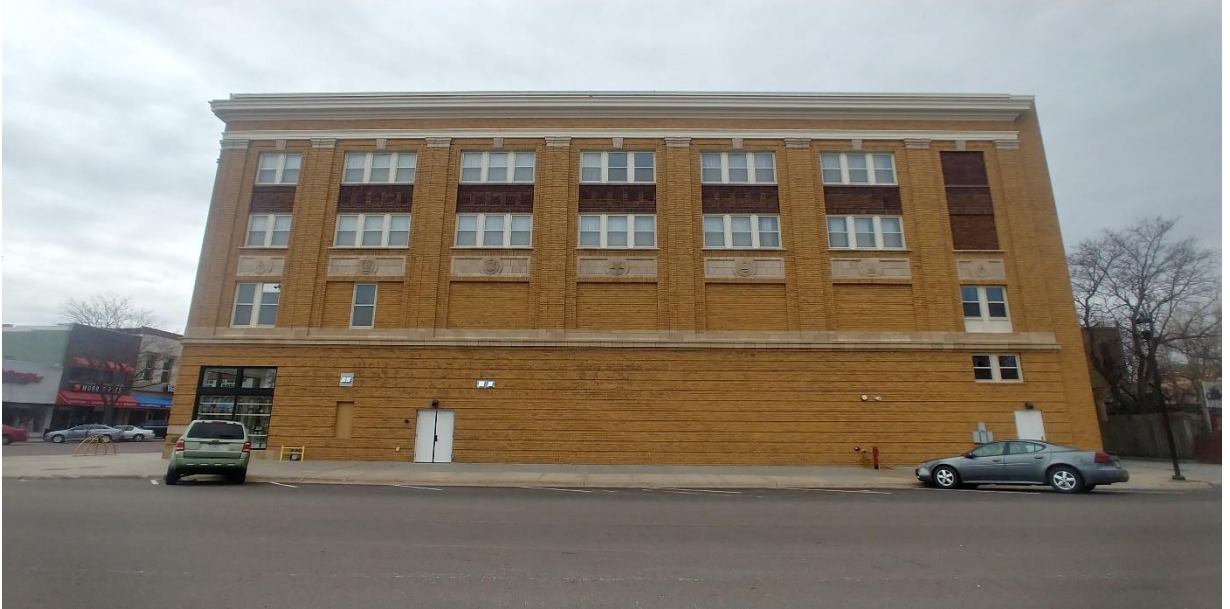
TETRA TECH PROJECT NO. 103X903019F0076 Direction: South	DESCRIPTION	This photo shows the property adjacent to and south of the site.	5
	CLIENT	U.S. Environmental Protection Agency Region 7	Date
	PHOTOGRAPHER	Thomas Kaley	4/22/2021

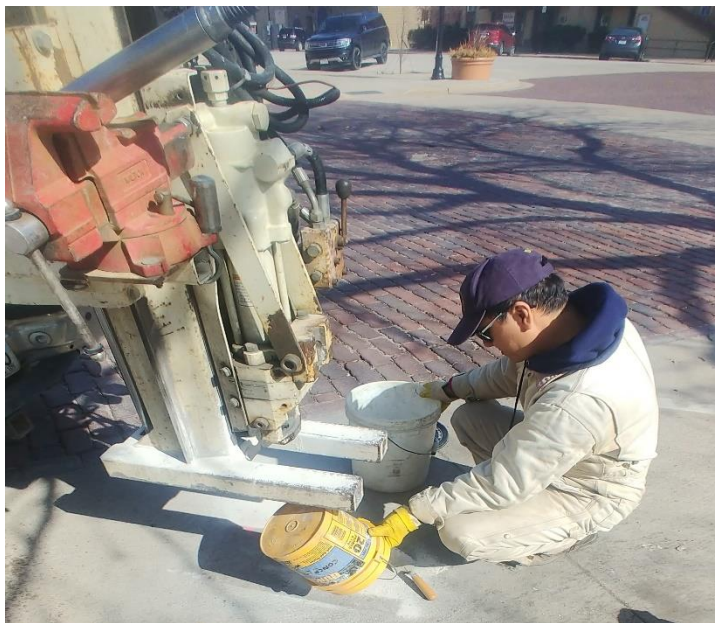
TETRA TECH PROJECT NO. 103X903019F0076 Direction: Southeast	DESCRIPTION	This photo shows Seagull personnel patching the concrete at TWS-19.	6
	CLIENT	U.S. Environmental Protection Agency Region 7	Date
	PHOTOGRAPHER	Thomas Kaley	4/21/2021

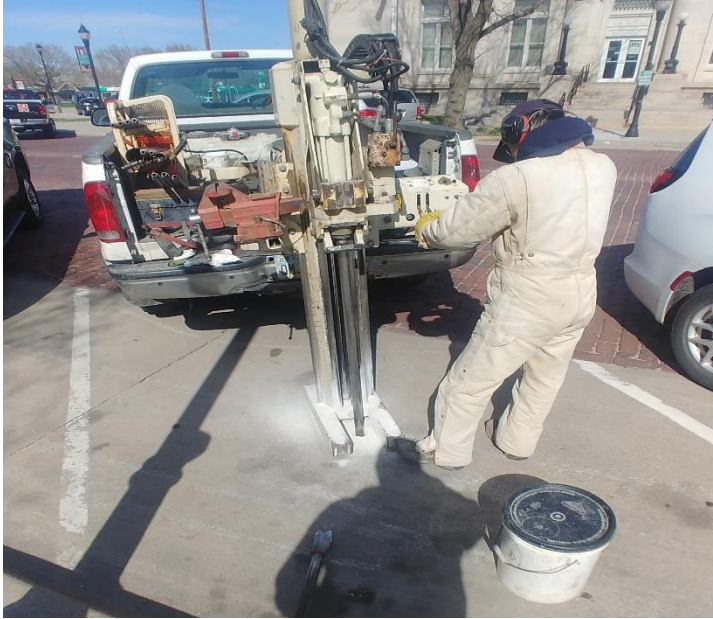
TETRA TECH PROJECT NO. 103X903019F0076 Direction: Northeast	DESCRIPTION	This photo shows Seagull personnel drilling TWS-20.	7
	CLIENT	U.S. Environmental Protection Agency Region 7	Date
	PHOTOGRAPHER	Thomas Kaley	4/21/2021

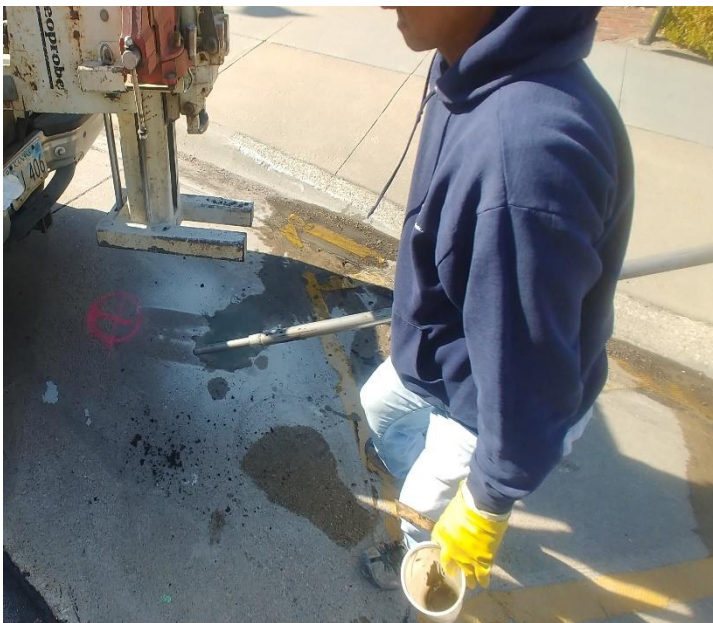
TETRA TECH PROJECT NO. 103X903019F0076 Direction: N/A	DESCRIPTION	This photo shows Seagull personnel finishing patching of the concrete at TWS-17.	8
	CLIENT	U.S. Environmental Protection Agency Region 7	Date
	PHOTOGRAPHER	Thomas Kaley	4/21/2021

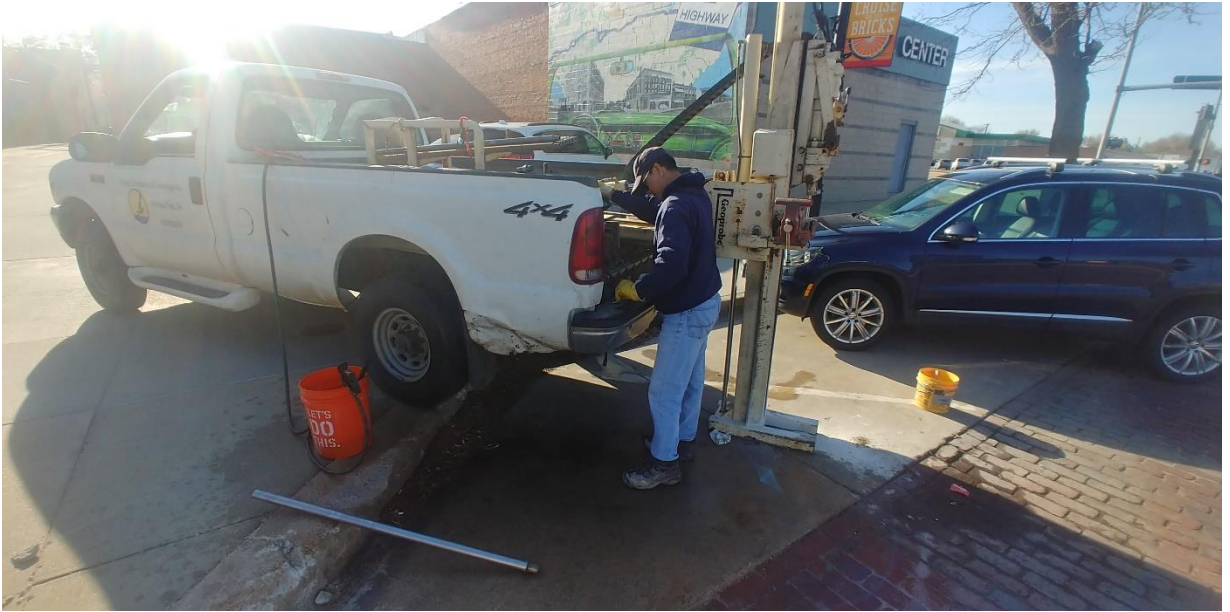
TETRA TECH PROJECT NO. 103X903019F0076 Direction: Northwest	DESCRIPTION	This photo shows Seagull personnel drilling at the new location for TWS-18.	9
	CLIENT	U.S. Environmental Protection Agency Region 7	Date
	PHOTOGRAPHER	Thomas Kaley	4/21/2021

During the sampling event on April 21, 2021, the location of TWS-18 (for background sampling) was to be northwest of the site; however, while drilling TWS-18 at that northwest location, and having penetrated the initial layer of concrete, personnel encountered another layer of concrete. This induced a decision to move the location for background sampling to Central avenue, north of the site. No other significant deviation from the QAPP occurred. Minor deviations did not adversely affect results of the PCS.

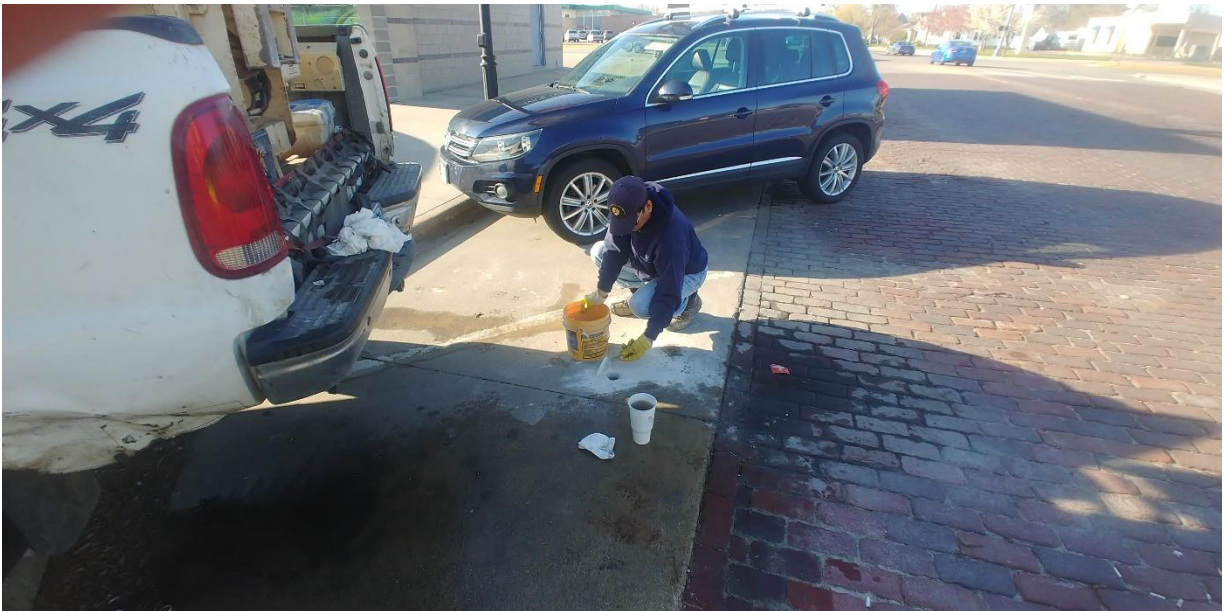
TETRA TECH PROJECT NO. 103X903019F0076 Direction: North	DESCRIPTION	This photo shows Seagull personnel patching concrete at TWS-18.	10
	CLIENT	U.S. Environmental Protection Agency Region 7	Date
	PHOTOGRAPHER	Thomas Kaley	4/21/2021
